## 7.0 Green River, Utah, Disposal Site

### 7.1 Compliance Summary

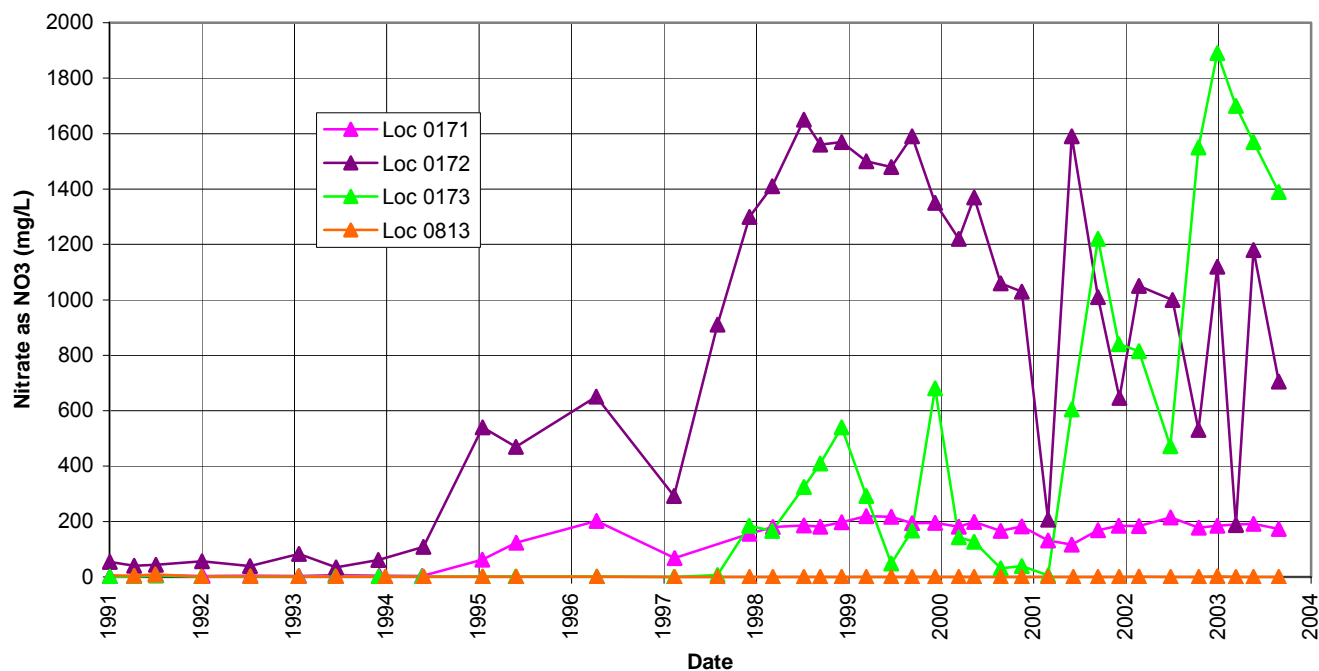
Figure 7–2. Time-Concentration Plots of Nitrate (as NO<sub>3</sub>) in Ground Water at the Green River, Utah, Disposal Site

**Ground Water Quality Monitoring**—Concentrations of nitrate in ground water continued above the proposed concentration limits (Table 7–2) except in well MW–0813, where values were very near the laboratory detection limit (Figure 7–2). Nitrate concentrations fluctuated slightly in well MW–0171, but there was considerable variation in the values for wells MW–0172 and MW–0173.

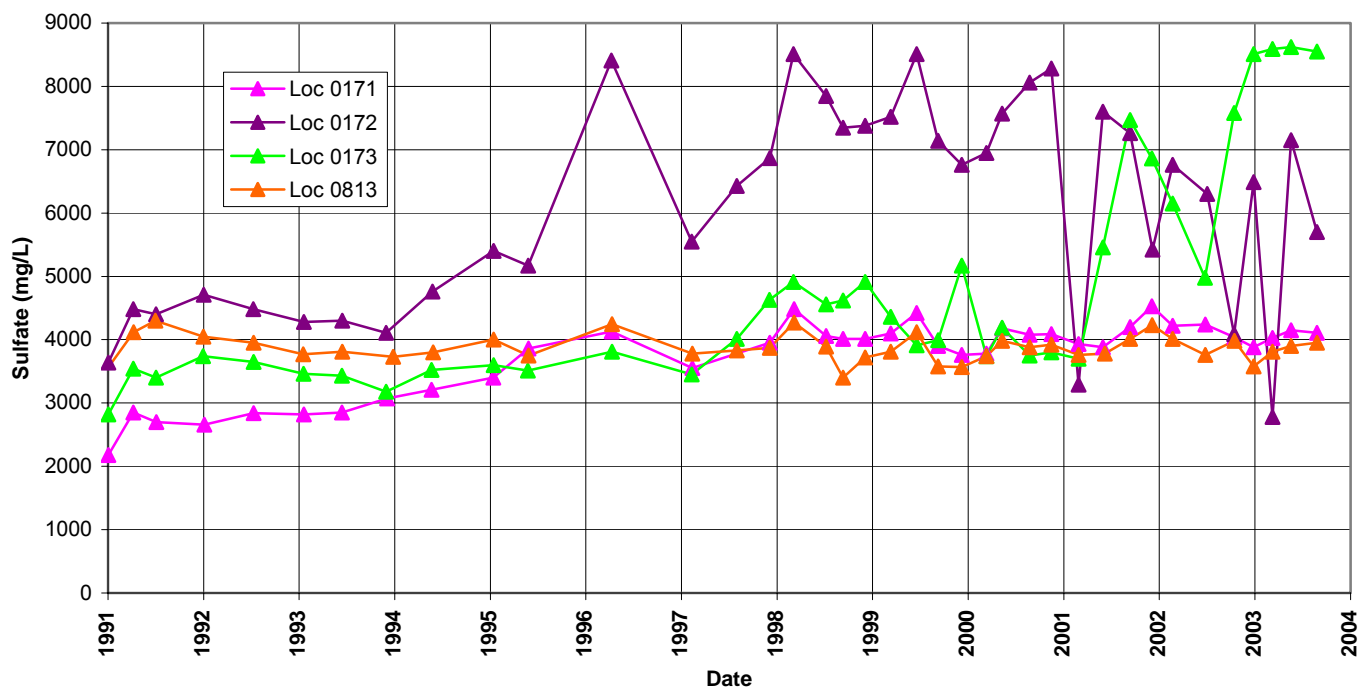
Figure 7-3. Time-Concentration Plots of Sulfate in Ground Water at the Green River, Utah, Disposal Site

Sulfate concentrations in ground water have remained relatively constant in wells MW–0171 and MW–0813 since the disposal cell was constructed (Figure 7–3). Concentrations in wells MW–0172 and MW–0173 have fluctuated substantially since 1996. Concentrations in 2003 continued above the proposed concentration limits (Table 7–2) in wells MW–0171, MW–0172, and MW–0173. Sulfate concentration was below the proposed limit in well MW–0813.

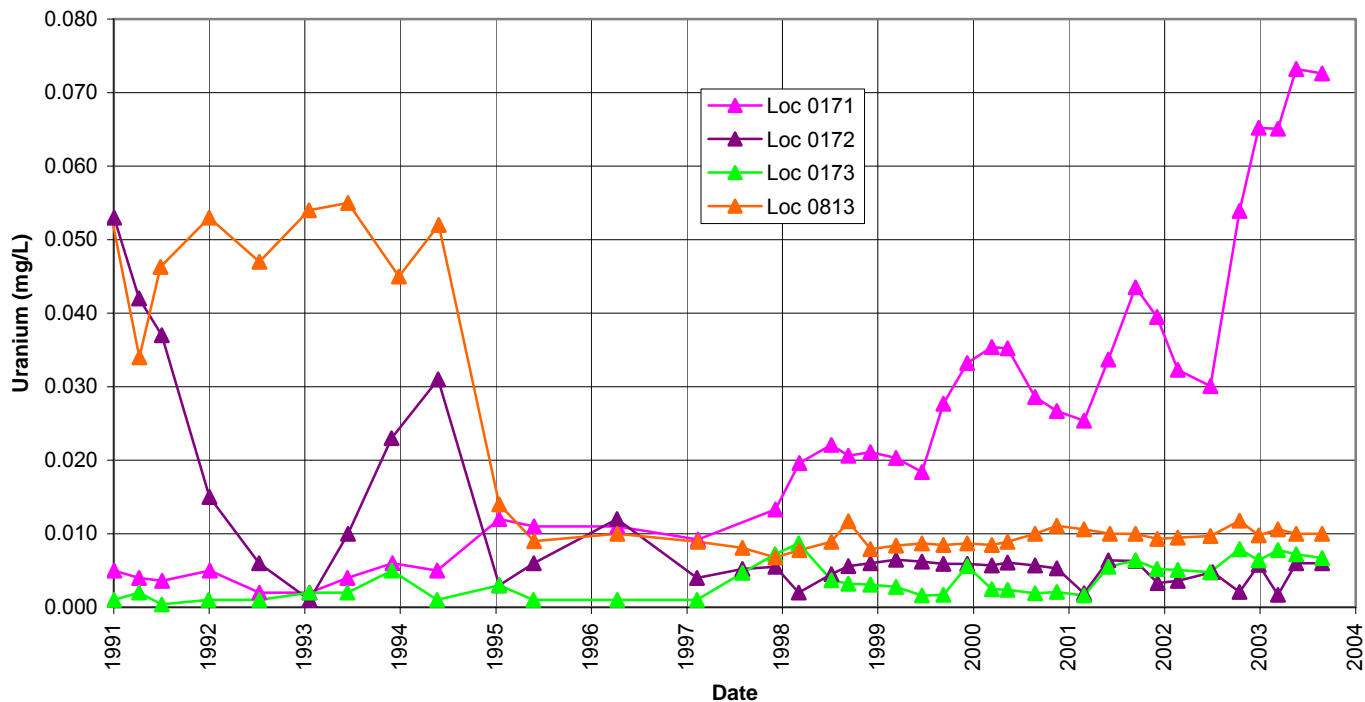
Figure 7-4. Time-Concentration Plots of Uranium in Ground Water at the Green River, Utah, Disposal Site

Uranium concentrations in ground water were below the proposed concentration limits (Table 7–2) in all four point-of-compliance wells from 1995 until October 2002, when levels exceeded the maximum concentration limit in well MW–0171 (Figure 7–4). The increasing uranium concentration in MW–0171 may be an indication of seepage from the disposal cell, as expected on the basis of the cell design and construction. Concentrations in the other wells remain fairly constant and at or below 0.010 milligrams per liter.

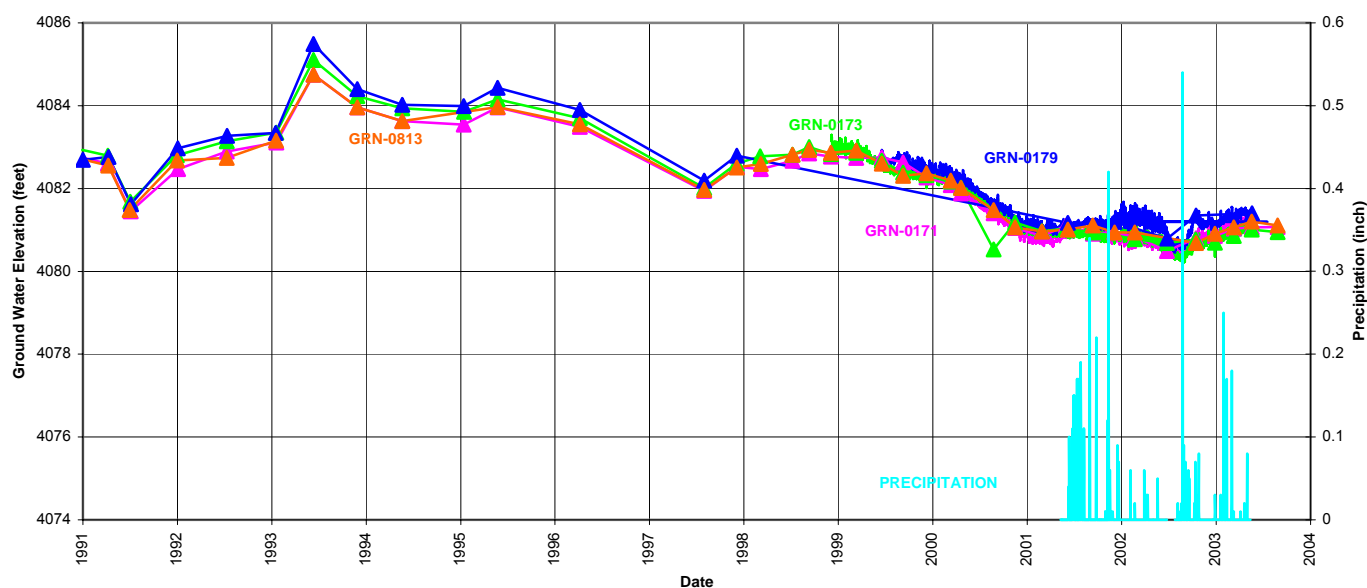
Figure 7-5. Ground Water Elevations and Precipitation at the Green River, Utah, Disposal Site

**Ground Water Level Monitoring**—Ground water levels in several monitor wells adjacent to the disposal cell have been measured manually since 1991, and continually with down-hole dataloggers for the past 5 years. Well hydrographs indicate an overall decrease in the ground water elevation of approximately 4 feet since 1993 (Figure 7–5).

A precipitation monitoring station was installed in the west corner of the secured site in 2001. DOE is evaluating the relationship between precipitation and ground water elevations near the disposal cell to determine if runoff from the cell has an impact on ground water flow at the site, which affects contaminant migration. Based on information collected to date, precipitation has been minimal, and there is no obvious correlation with ground water elevations measured by dataloggers in the wells adjacent to the disposal cell (Figure 7–5).

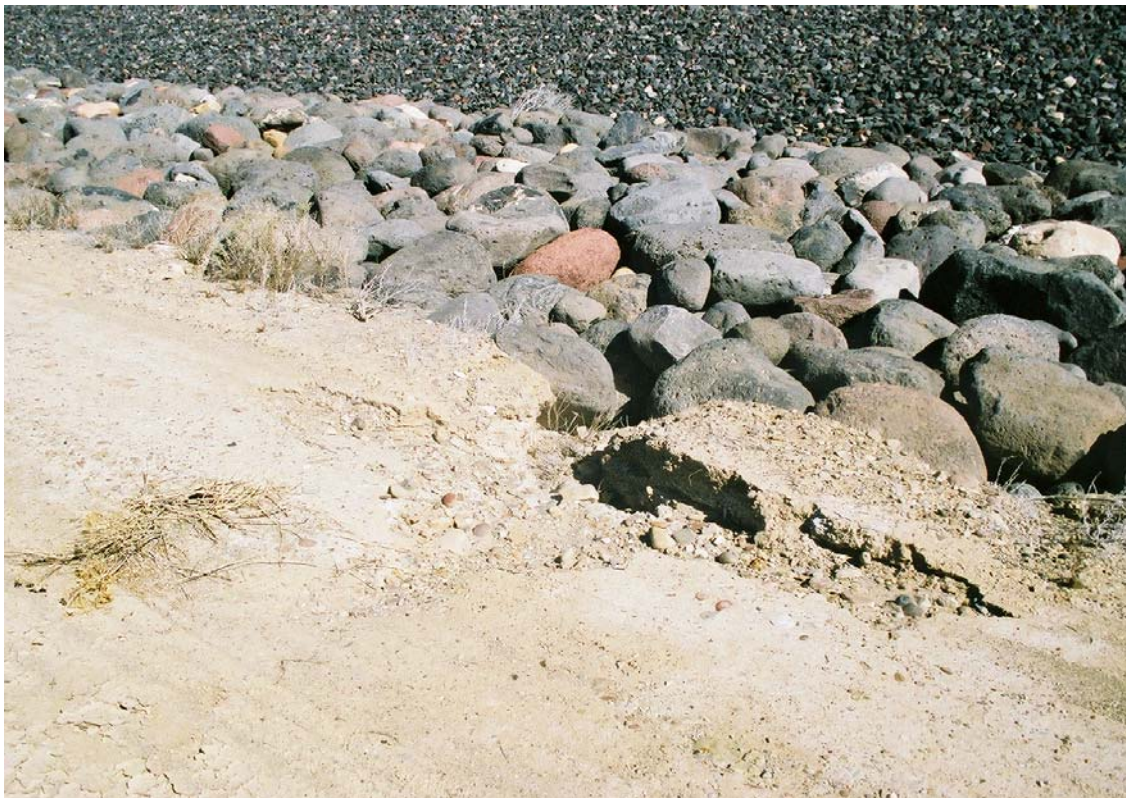
7A The riprap-filled diversion channel (apron) along the base of the disposal cell on all sides was in excellent condition. Runoff from a storm event in fall 2002 resulted in minor sediment deposition near the south corner of the cell and created two small gullies in the cell perimeter road as the water drained into the apron (PL–1). The erosion did not present a threat to the integrity of the cell; however the gullies were filled and minor site grading was performed to divert runoff water away from the cell apron.

*GRN 03/2003. PL-1. Erosion in the cell perimeter road along the southwest side of the disposal cell.*

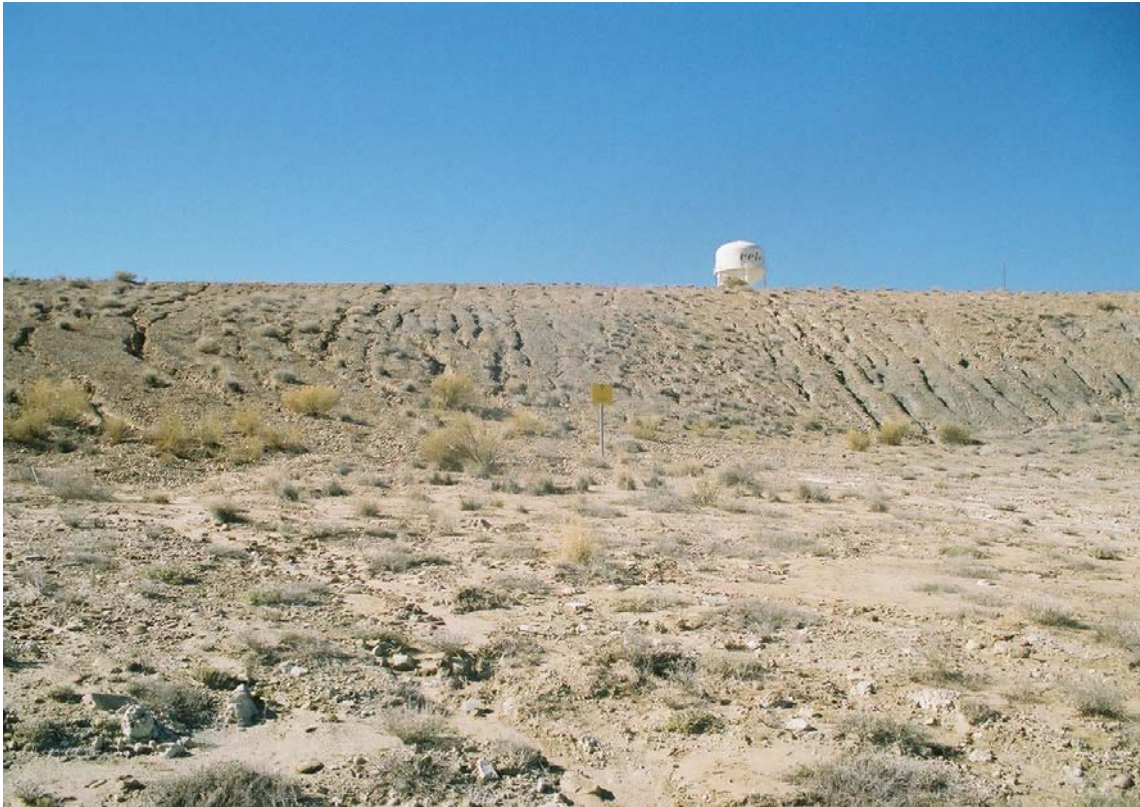
Rill and gully erosion noted during previous inspections on the hillside northeast of the disposal cell in the area between boundary monument BM-7 and survey monument SM-3 appears to have increased (PL-2). Maximum gully depth in this area is approximately 3 feet. The rill and gully erosion poses no threat to the integrity of the disposal cell but eventually could damage perimeter signs and boundary monuments; therefore, monitoring of erosion in this area will continue.

*GRN 03/2003. PL-2. Erosion along the north side of the property near perimeter sign P11.*
